A COMMERCIAL APPLICATION OF
VIROFLOW™ TECHNOLOGY

CASE STUDY BLAYNEY TREATED PINE

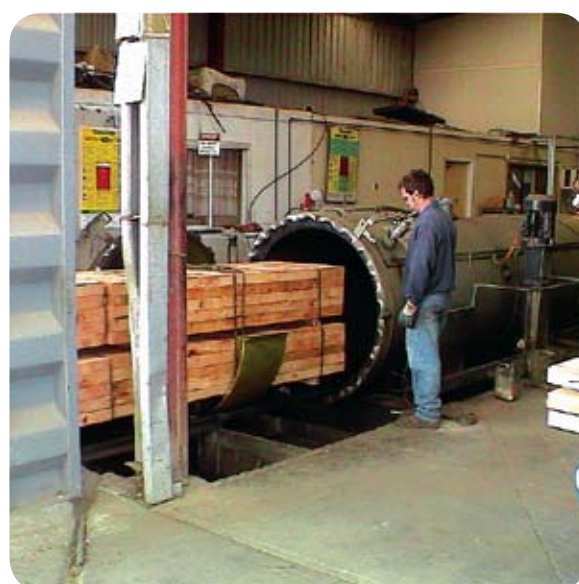
Timber being loaded into the treatment vessel.
