*A COMMERCIAL APPLICATION OF  
VIROMINE™ TECHNOLOGY*

## CASE STUDY TAILINGS TREATMENT AT KING RIVER DELTA, TASMANIA

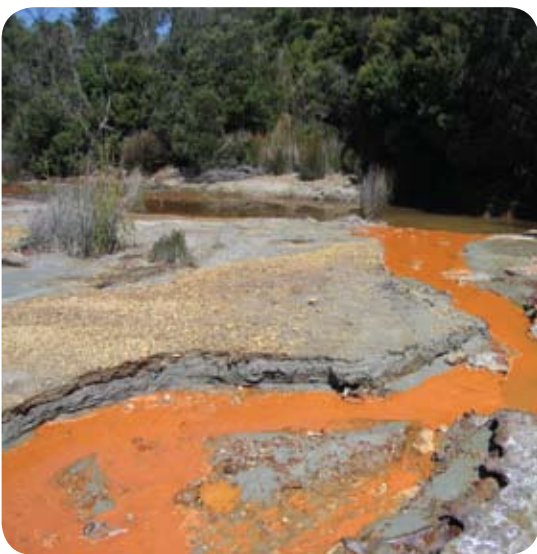
*Polluted water entering King River*

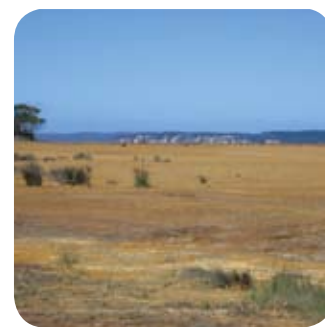
The King River tailings delta

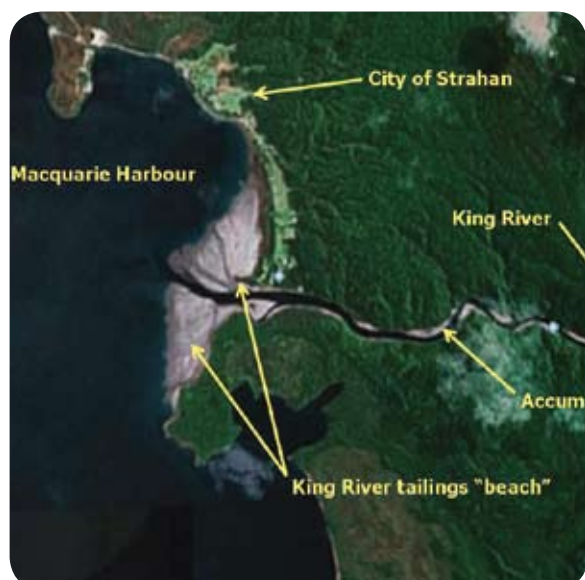
Aerial view of the King River flowing southwest into Macquarie Harbour (centre right to centre left) and the King River tailings delta (centre left). Pockets of oxidized tailings can be clearly seen along the banks of the river although most of the tailings accumulated around the river mouth.

of toxic tailings, covers about 3.5 square kilometres across the mouth of the King River (see Figure 1). Major toxic contaminants in the tailings include: arsenic, chromium, copper, lead, mercury, nickel, selenium and zinc. With the help of Federal Government funding, a remediation project designed to independently assess several treatment methods was undertaken by local government and residents. The goals of the project were to determine the optimum method for binding heavy metals and providing the tailings with enough nutrients to support long-term grass and tree growth.

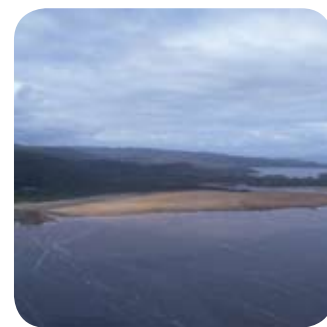
*Aerial photograph (looking south) showing the tailings “beach” at the mouth of the King River; Macquarie Harbour is in the foreground.*

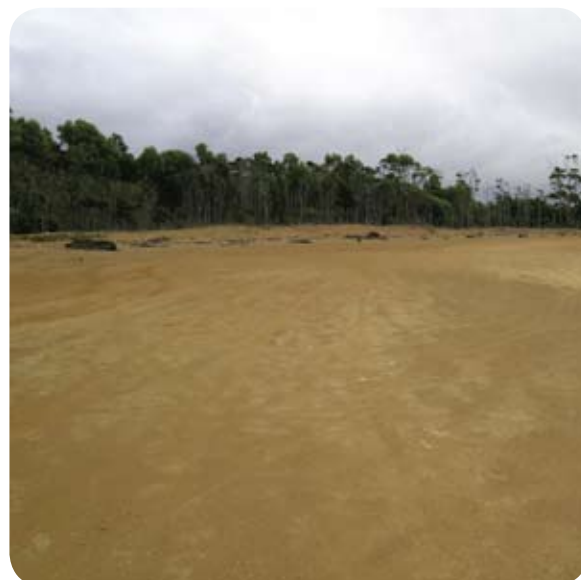
*Photograph of the King River delta tailings beach. Note that after 100 years, nothing grows on the tailings because acidity and mobile metal concentrations are too high to support plant growth.*

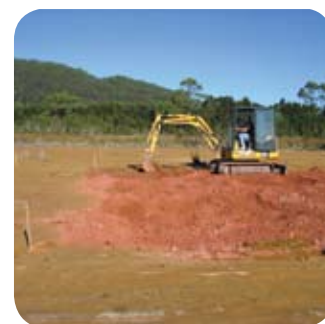
*The Terra B™ reagent was spread and mixed into the tailings using an excavator.*

1. initial sample analysis and treatment strategy development;
2. the development of a specially blended Terra B™ reagent designed for the site (the reagent was blended in Strahan prior to application);
3. transport to the treatment site and application of the Terra B™ reagent, including spreading, mixing and planting;
4. on-site project management; and
5. post-treatment analysis.

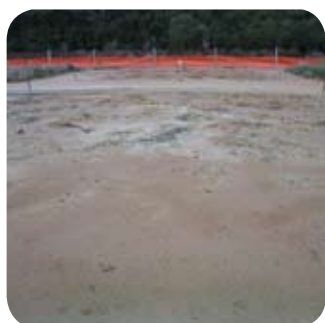
Photograph showing the 200m<sup>2</sup> untreated control area on the tailings; note the complete absence of vegetation after 12 months.

The research areas, which had been treated with other methods (lime and fertiliser addition, sand addition or soil addition), showed little or no sign of improvement. Figure 6 shows the control area and Figure 7 shows the lime-treated area 12 months after treatment. The control area did not support any grass or tree growth whereas the lime-treated area supported sporadic grass growth but was considered unlikely to support any long-term vegetative cover, and was classed a failure. Previous field trials elsewhere had shown that, due to the moderately high solubility of lime, treating tailings with lime results in a short-term pH adjustment and reasonable plant growth but a return to acidic conditions and the release of mobile metals usually occurs within about 18 months and any vegetation that has taken hold begins to die off.

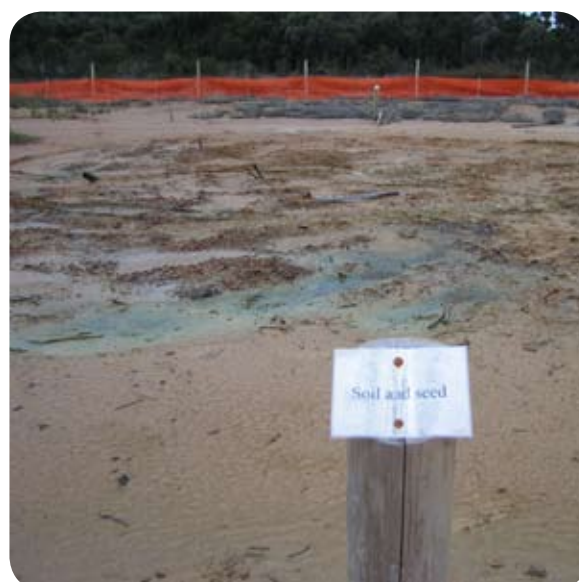
*Photograph showing the condition of of the 100m2 lime and fertiliser treated plot 12 months after treatment; note pools of salt water that have accumulated on the treated area as a result of seawater inundation.*
