*A COMMERCIAL APPLICATION OF
VIROSEWAGE™ TECHNOLOGY*

**CASE STUDY
SHANDON LAGOON
SOUTH CAROLINA, USA**

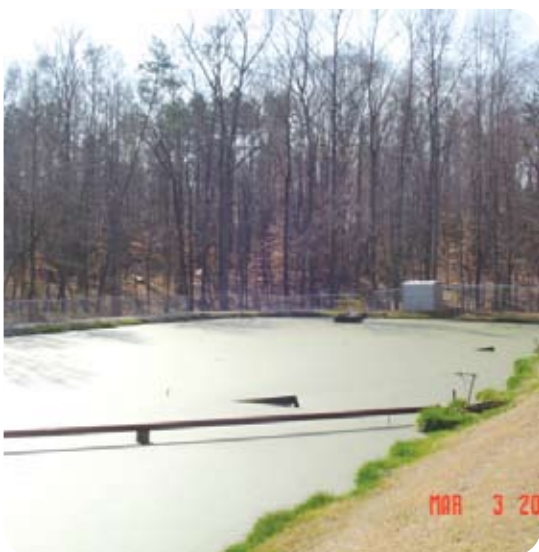
Shandon Lagoon prior to treatment

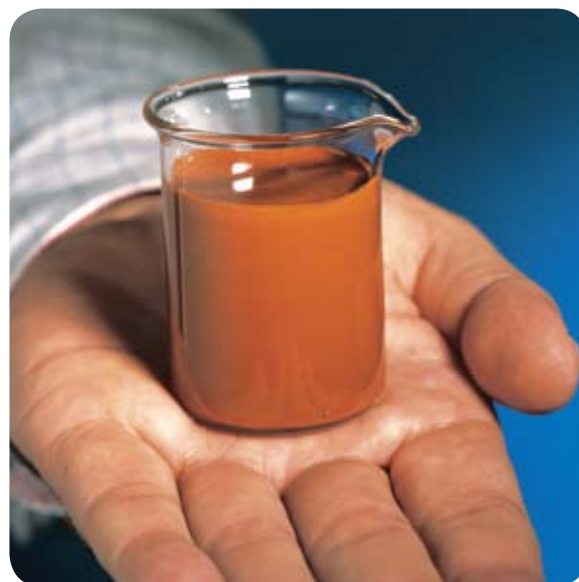
All samples were taken from three previously designated sample points; the influent side of Lagoon #1, the middle discharge (outflow) of Lagoon #1, and the final discharge outflow from Lagoon #2. Treatment of Lagoon #1 using ViroSewage™ Technology Reagents.

The ViroSewage™ Technology reagents were applied in slurry form to Lagoon #1. Depending on the application ViroSewage™ Technology reagents in powder or pellet form can also be used.

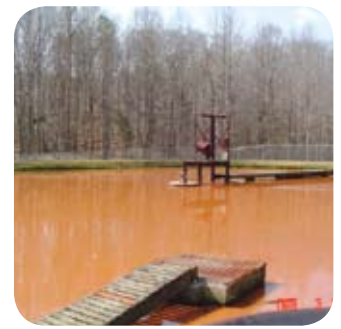
Treatment of Lagoon #1 using ViroSewage™ Technology Reagents. The coloured reagent settled to the bottom of a treated water body within 48 hours.

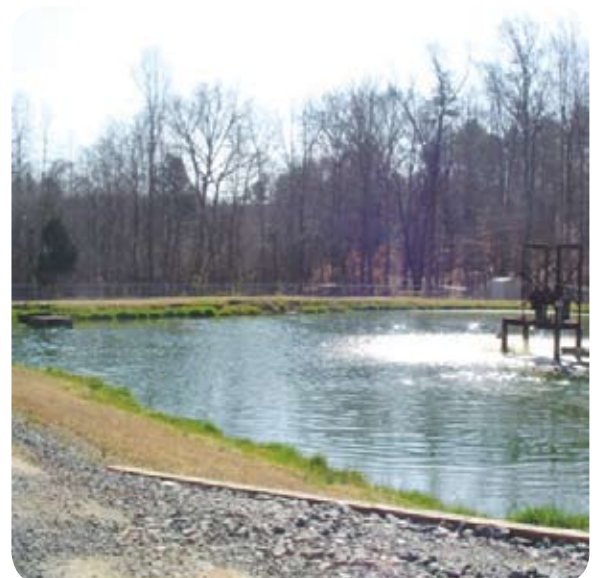
Lagoon #1 after treatment using ViroSewage™ Technology
