*A COMMERCIAL APPLICATION OF  
VIROSOIL™ TECHNOLOGY*

**CASE STUDY  
PELICAN GOLF COURSE  
QUEENSLAND, AUSTRALIA**

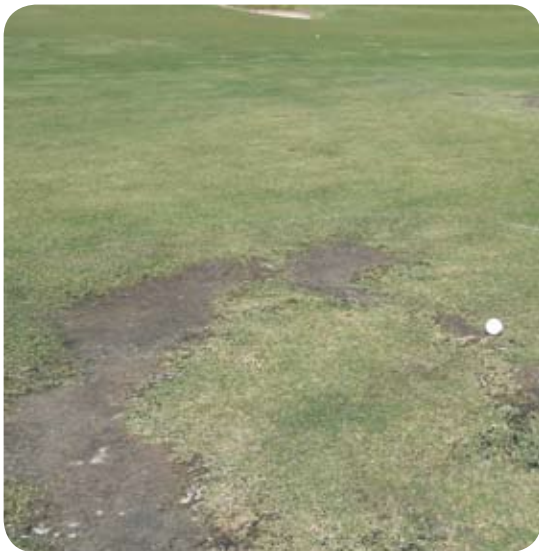
*Areas of the fairway affected by acid scalding after treatment with ViroSoil™ Technology.*

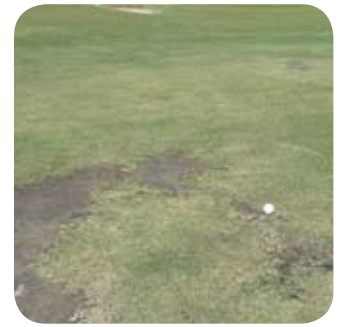
*Turf had previously been laid several times due to acid scalding.*

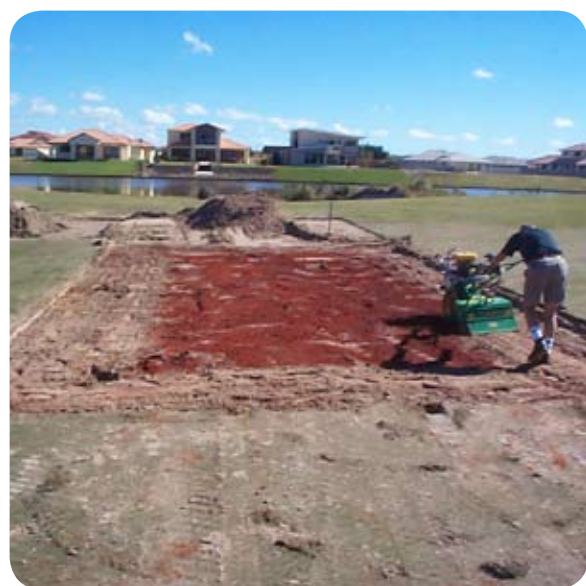
*Mixing the ViroBind™ reagent into the sand and clay of the first treatment area by rotary hoe.*

Three treatment areas were identified, with the first (in the foreground of Figure 3) being an area of substantial acid scalding to which the ViroBind™ reagent was applied as a layer at a depth of about 100mm and mixed lightly by rotary hoe. The second treatment area (in the back-ground of Figure 3) was a similar size area where ViroBind™ reagent was thoroughly mixed with the clay and sand components to a depth of approximately 200mm. The third treatment area (to the left in the background of Figure 3) was a control area that was simply stripped and re-turfed with no addition of ViroBind™ reagent. The surrounding fairway, which still had many areas of scalding, served as a further control area where no disturbance to the turf or soil occurred.

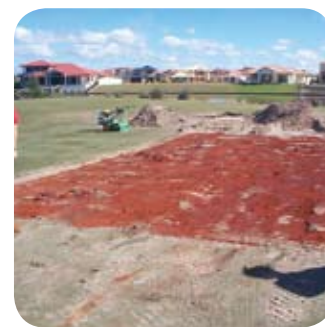
*Mixing the ViroBind reagent into the sand.*

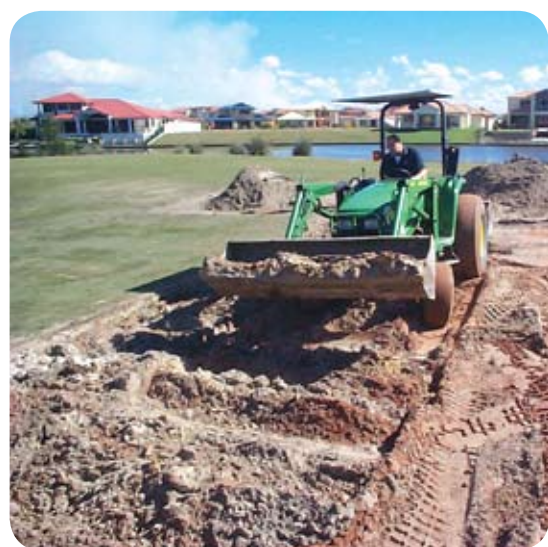
*Top soil being applied to the area prior to turf being laid.*

a blending ratio to be determined by Virotec's computerised ASS treatment model, and the turf would be replaced together with some fresh top soil over the project area. The treatment areas would be monitored but largely left to weather for six to eight months and then re-sampled to assess the ASS characteristics of the soil.

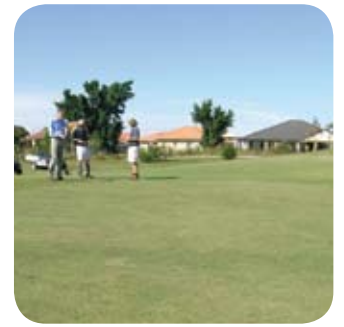
Area treated with ViroSoil™ Technology shows no signs of scalding after 8 months.
