ONE OF THE LARGEST PORT AUTHORITIES IN AUSTRALIA WAS CHANGING ITS RAILWAY LAYOUT. APPROXIMATELY 30,000 CUBIC METRES OF SULPHIDIC MARINE CLAYS FROM PAST DREDGING AND LAND RECLAMATION WAS EXCAVATED AND STOCKPILED AND STARTED TO OXIDIZE AND BECAME ACIDIC.

MARINE ENVIRONMENTS CAN BE SO TRICKY

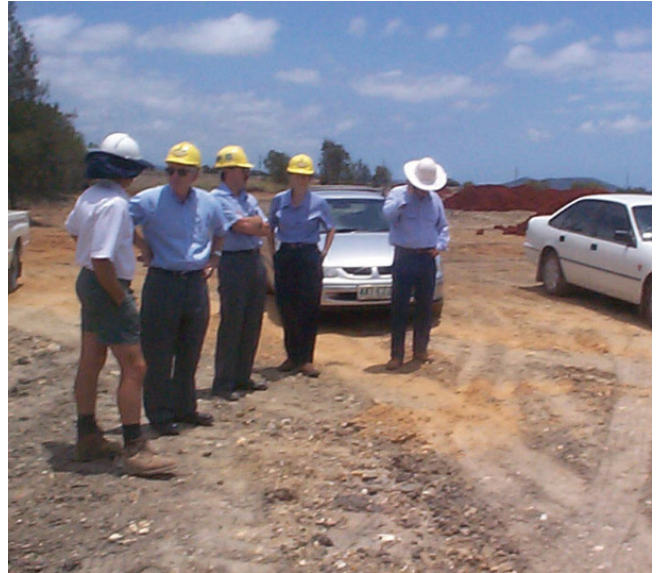
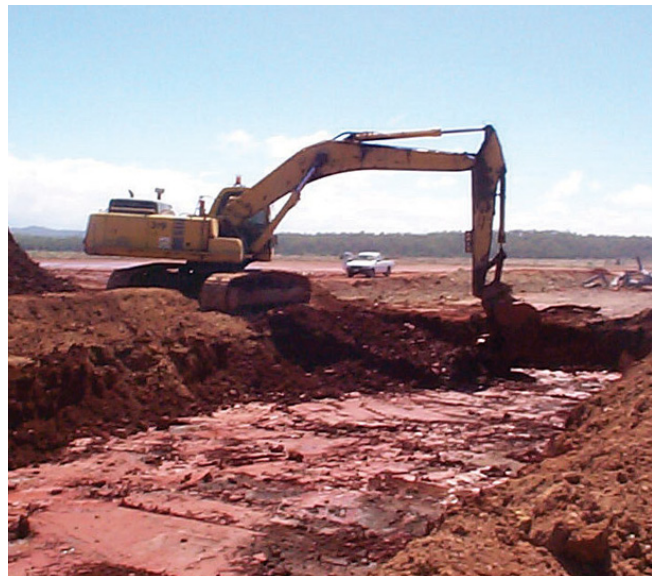
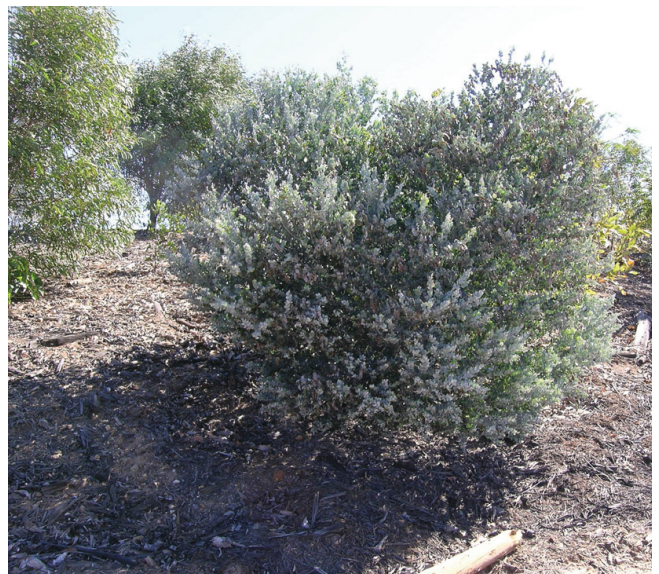
It was now a case of waiting 2 years to see what happened. And you guessed it. Today that site looks like natural vegetation, monitored results are great and the leachate and runoff from the site is of good quality.

The Port Authority are more than happy - "there has been no adverse affect or public comment and the remediated soil colour is now brown which has a much better appearance than the black marine clay. This was a test for Virotec and they passed with flying colours".

The affected soil was levelled to a thickness of approximately one metre, the required quantity reagent was spread over the surface and blade mixed with the soil and finally, the remediated soil was dozed to the required shape to form a landscape buffer.

It was then a case of test and analyse to see if we got it right. Piezometers were bored at strategic site locations to monitor ground water seepage from the soil. 80% of the returned samples gave negative NAGP results within 24 hours which was a good first hit, and the areas with a positive NAGP were retreated.

Very quickly 100% of all sulphides present within the sediments were neutralised and the average soil pH increased from 4.04 to 6.81. So far so good.

We then put on our horticultural hat. After more soil testing to get the soil to the optimum revegetation level, we had to add phosphate fertilizer and organic matter to enhance nutrient retention, retain water and promote vigorous plant growth.
