**ONE OF THE LARGEST PORT AUTHORITIES IN AUSTRALIA WAS CHANGING ITS RAILWAY LAYOUT. APPROXIMATELY 30,000 CUBIC METRES OF SULPHIDIC MARINE CLAYS FROM PAST DREDGING AND LAND RECLAMATION WAS EXCAVATED AND STOCKPILED AND STARTED TO OXIDIZE AND BECAME ACIDIC.**

#### **MARINE ENVIRONMENTS CAN BE SO TRICKY**

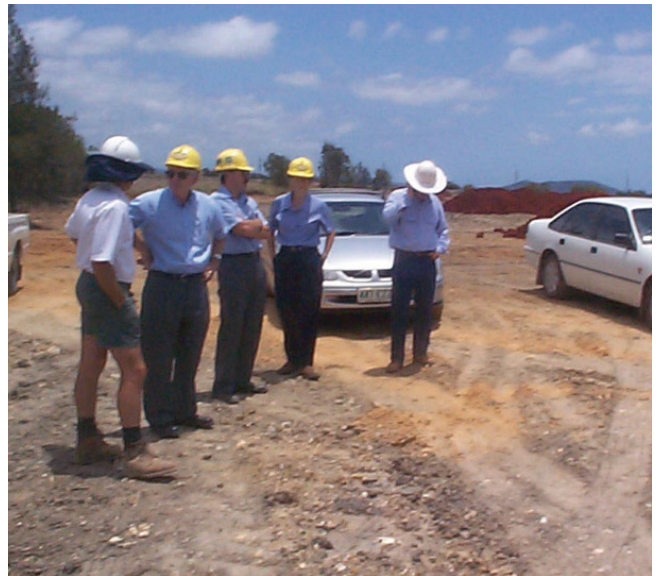
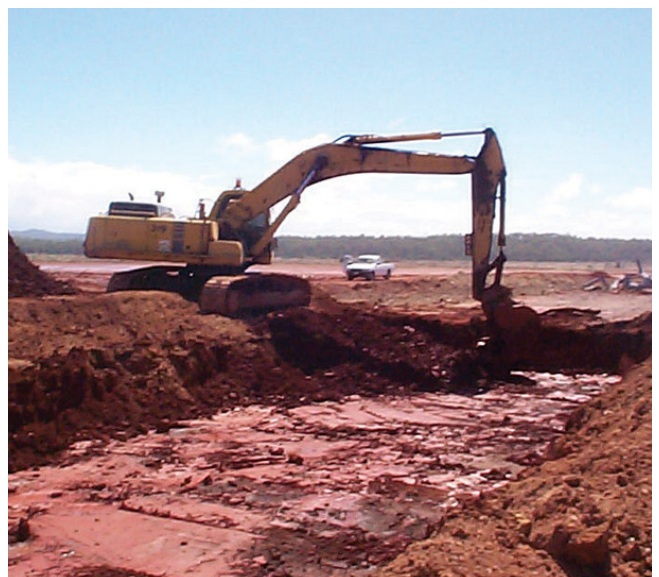
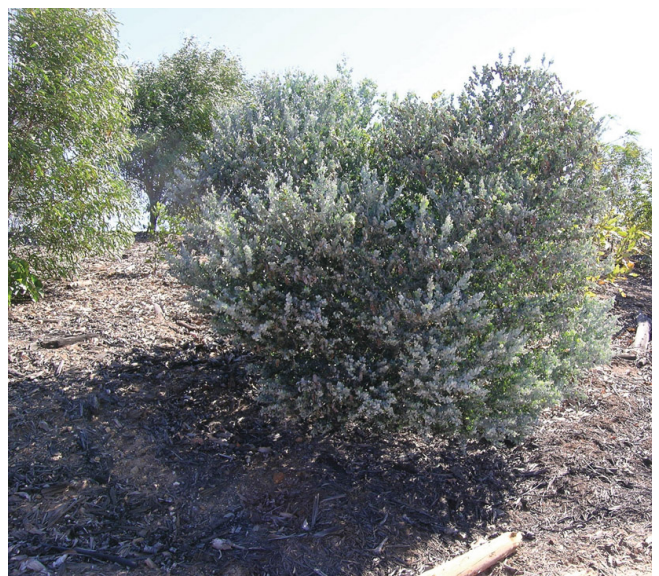
The affected soil was levelled to a thickness of approximately one metre, the required quantity reagent was spread over the surface and blade mixed with the soil and finally, the remediated soil was dozed to the required shape to form a landscape buffer.

Very quickly 100% of all sulphides present within the sediments were neutralised and the average soil pH increased from 4.04 to 6.81. So far so good.

It was now a case of waiting 2 years to see what happened. And you guessed it. Today that site looks like natural vegetation, monitored results are great and the leachate and runoff from the site is of good quality.
