*A COMMERCIAL APPLICATION OF  
VIROFLOW™ TECHNOLOGY*

**CASE STUDY  
HYNE TIMBER, MARYBOROUGH,  
QUEENSLAND, AUSTRALIA**

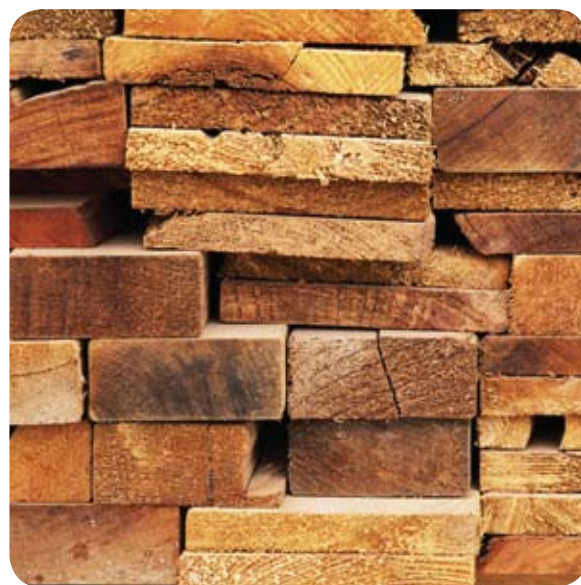
*With the CCA treatment process, copper and arsenic protects timber from insect and fungal degradation. Chromium seals the copper and arsenic into the timber.*

a more effective impregnation. The chemical treatment used is known as CCA. Copper and arsenic protect the timber from insect and fungal degradation, and chromium is used to chemically seal the copper and arsenic into the timber.

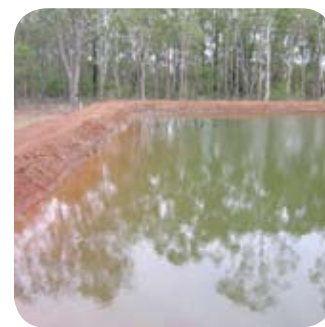
*Pond #1 after ViroFlow™ Technology treatment.*

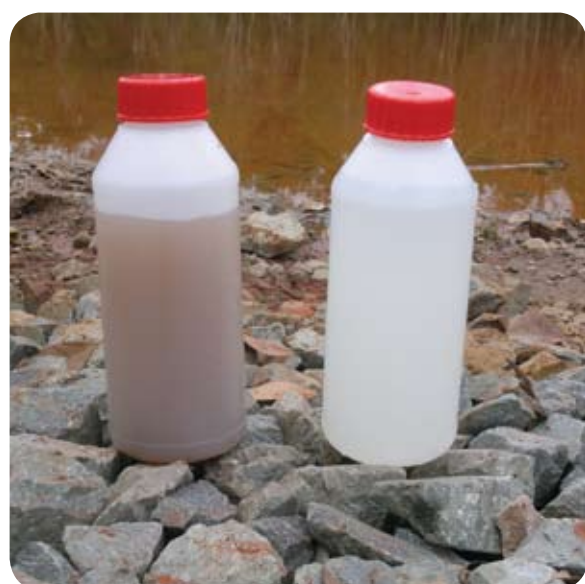
*Application of ViroFlow™ Technology produced a remarkable improvement in pond water clarity. (Left:) Before treatment. (Right:) After treatment with ViroBond™*
