*A COMMERCIAL APPLICATION OF
VIROFLOW™ TECHNOLOGY*

**CASE STUDY
SOLID WASTE TREATMENT,
JEDDAH, SAUDI ARABIA**

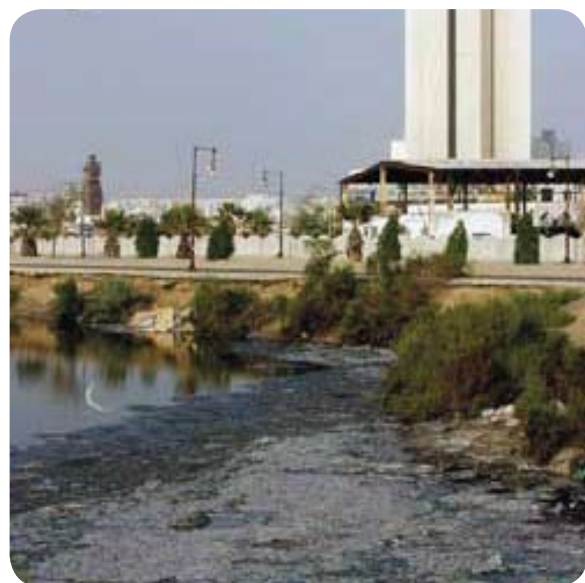
Raw sewage in creeks, streams and lakes is common in Jeddah.

Despite Saudi Arabia generating a gross national product of US\$380 billion per year, the provision of sanitary sewage treatment and disposal systems in the city has been slow in coming. The problem was compounded by an outbreak of dengue fever in Jeddah during 2006, at which time the entire city completely closed down to outsiders while the disease was contained. Images of raw sewage in the middle of the city (e.g. Figure 1) are commonplace.

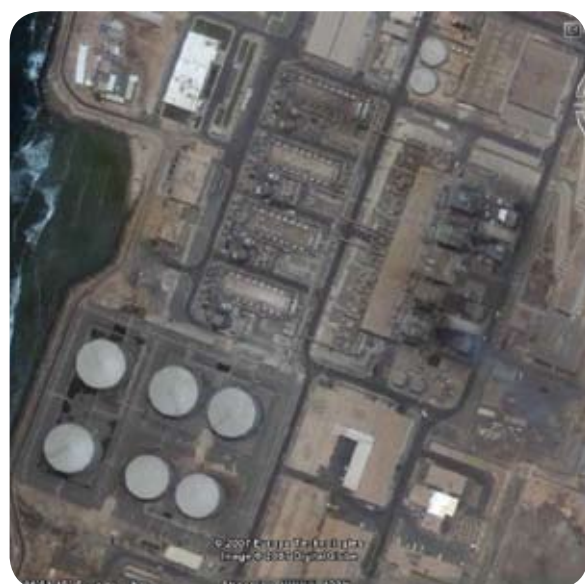
Figure 3: Aerial photograph of a desalination plant in Jeddah (centre). The Red Sea is to the west of the plant and the city is one kilometre to the north and immediately east of the plant. Note the co-generation power plant adjacent to and immediately east of the plant (centre right).

The desalination plant at Jeddah is linked to a cogeneration power plant at the site (Figure 3); fly ash from the power electric plant, used to fire the multi-stage flash distillation process, is dumped into the Red Sea. However, due to the prevailing wind system, much of this ash is blown back onto the beaches of Jeddah and is a source of significant pollution along the foreshore of the city to the north. Moreover, much of this ash is contaminated with oil from the Suez region and when this oil is mixed with fly ash, it produces a sticky, smelly and contaminated solid waste that pollutes the beaches of Jeddah.

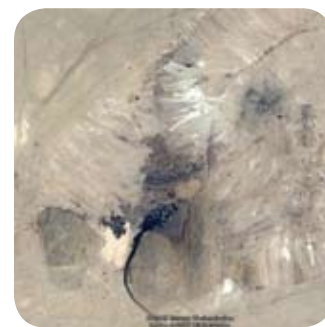
Aerial photograph of Briman Lake. Trucks enter the site from the north (top right) with seepage running to the west and south of the dump (centre bottom); the city of Jeddah is three kilometres to the west.

The dumping site for Jeddah's municipal sewage and industrial solids is located at the east side of the city, in a valley surrounded by medium to low relief mountains that create an artificial dump called "Briman Lake" (see Figure 2), about one kilometre by one and a half kilometres in area. The city is adjacent to the dump in the west and south. The location of the dump is particularly unfortunate, because the general topography means there is a slope from north to south and from east to west, with leachate from the waste flowing back toward Jeddah.

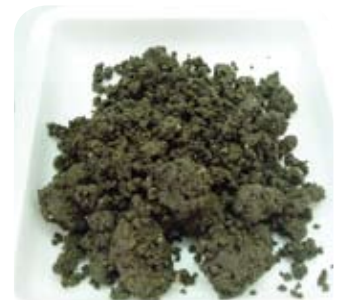
Solid waste from a municipal treatment plant.

Solid waste from a municipal waste treatment plant; a blackish-brown, moist “filter cake” mixed with sandy material (see Figure 4). The waste was spongy or rubbery in texture, and was typical of biosolids previously treated and reused by Virotec.

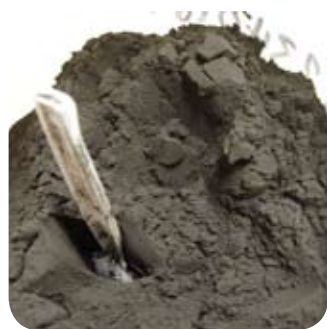
Briman Lake solid waste.

Briman Lake sediment (or “dredge spoil”); a fine, black, dry powder (see Figure 6), typical of dredge spoil previously treated and reused by Virotec.

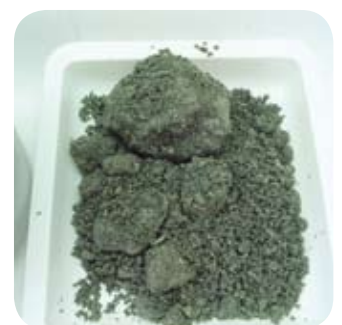
Solid waste washed up on the beach at Jeddah.

This solid waste was collected from a Jeddah beach after washing up from the Red Sea; a grey, slightly moist, ash-sand mixture (see Figure 5), including shell pieces 10-50 mm long and small sticks. Upon receipt, the waste had a wet, sandy non-offensive odour typical of ash solids previously treated and reused by Virotec.

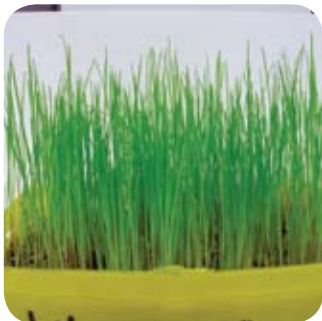
Figure 7

Grass growth in treated Waste #1 seven days after planting and germination.

The following photographs (Figures 7, 8, 9, 10, 11 and 12) show the growth of grass in the three treated wastes seven days after treatment with ViroGrow™ reagent, and compare this growth to grass growth in the untreated waste solids.

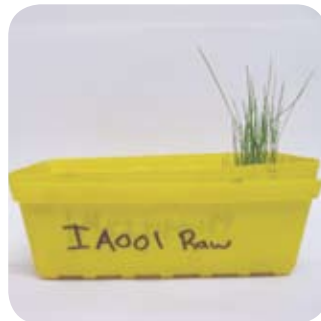
Figure 8

Grass growth in untreated Waste #1 control seven days after planting and germination.

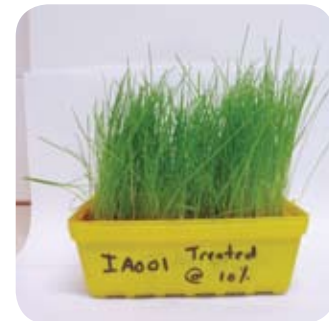
Figure 9

Grass growth in treated Waste #2 seven days after planting and germination.

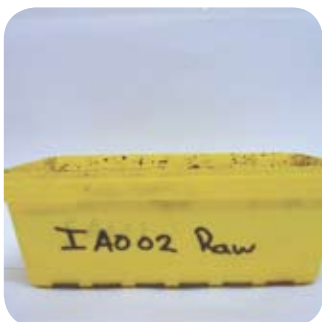
Figure 10

Grass growth in treated Waste #2 control seven days after planting and germination.

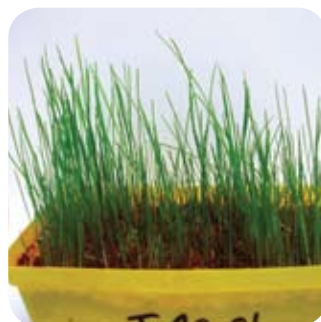
Figure 11

Grass growth in treated Waste #3 seven days after planting and germination.

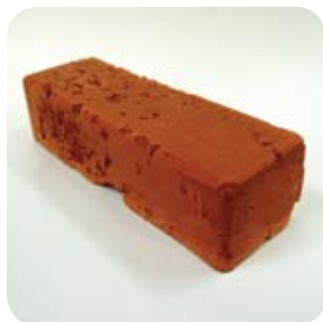
Figure 13

The type of brick that can be manufactured from Waste #1. Note the porosity of the brick, which may be beneficial in some forms of paver or building material.

The following photographs (Figures 13, 14 and 15) and data (see Table 7) present the results from the solidification and brick manufacturing trials. The work was carried out to determine if the waste solids could be both treated for contaminants as well as reused after treatment in some form of building construction or as a road building material.

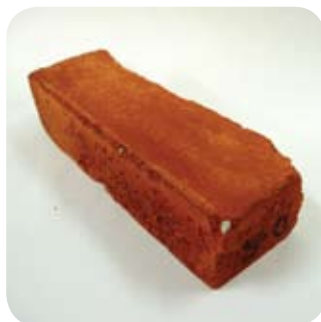
Figure 14

The type of brick that can be manufactured from Waste #2. Note the porosity of the brick, which may be beneficial in some forms of paver or building material.

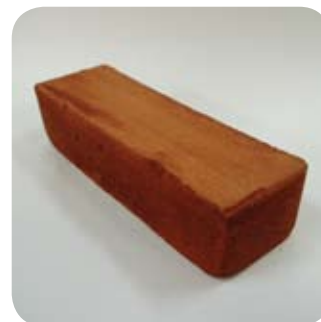
Figure 15

The type of brick that can be manufactured from Waste #3.
