*A COMMERCIAL APPLICATION OF  
VIROFLOW™ TECHNOLOGY*

**CASE STUDY  
LARGE CCA TREATMENT PLANT**

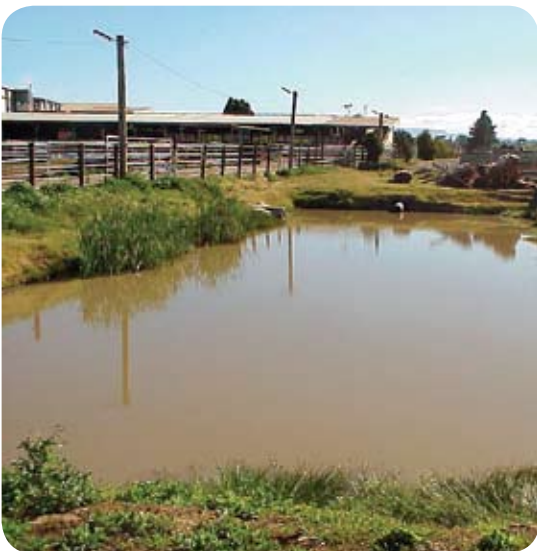
*A leachate pond, with heavy metal concentrations, that was successfully treated with ViroFlow™ Technology.*

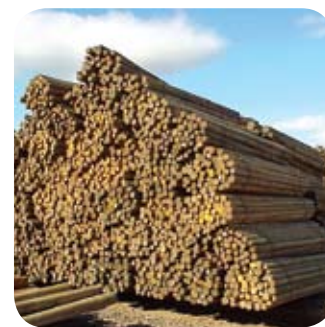
*Air-dried treated logs.*

After treatment, the logs are stored in a holding bay, where they are air-dried. During the warmer months the minimum holding time is five days, whereas the minimum holding time in the colder months is 12 days. Water containing CCA often seeps from the logs as they are drying. The leachate is contaminated with copper, chromium and arsenic and when it rains, it is washed into collection ponds at the back of the site.

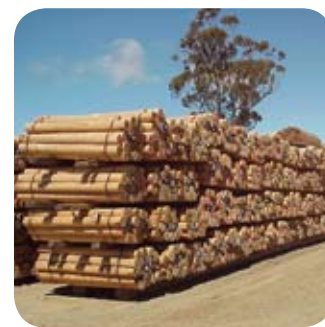
*The treated timber storage.*

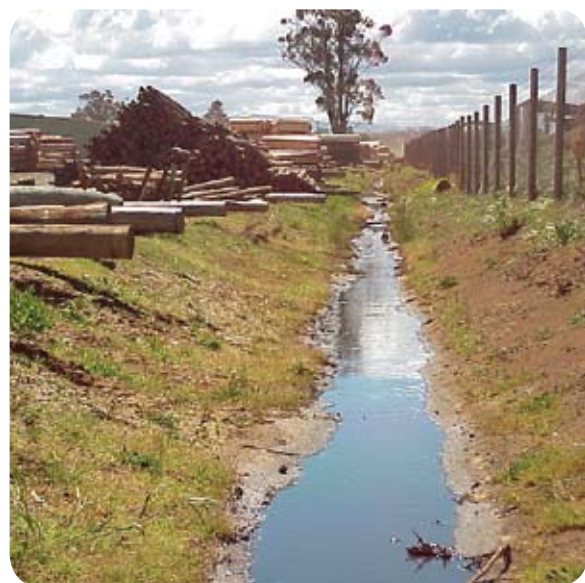
*The stormwater drain leading from the timber storage area to leachate pond.*

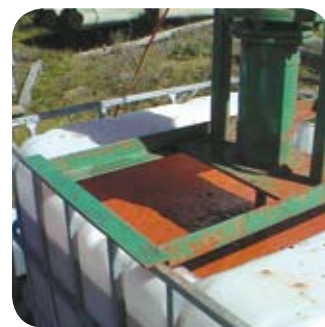
Pre-mixing of ViroBind™ reagent Part A.

ViroBond™ Reagent Part A was premixed in a mixing vessel (see Figure 6) and subsequently sprayed over the surface of the ponds. The spent reagent was allowed to settle and form a blanket over the bottom of the ponds, where metals were permanently trapped. The pond pH was increased to 9.0 after addition of ViroBond™ Reagent Part A.

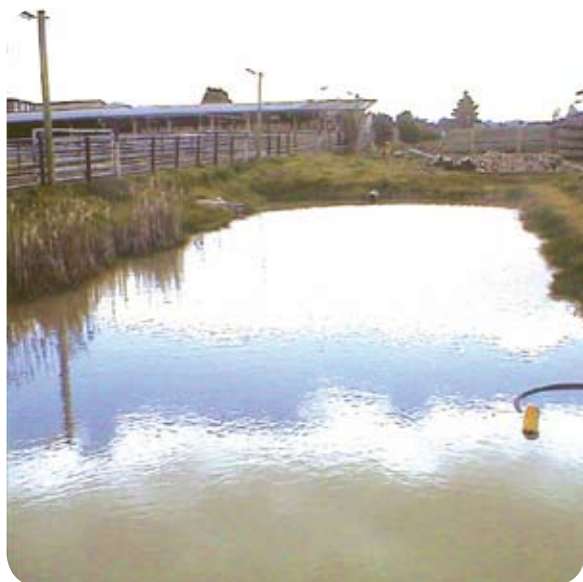
Pond No. 1 after Treatment.

The figure below show the visual appearance of the leachate pond No. 1 post treatment. It was noticed that there was a substantial improvement in water clarity and odour.
