*A COMMERCIAL APPLICATION OF
VIROFLOW™ TECHNOLOGY*

**CASE STUDY
PARKSIDE TIMBER**

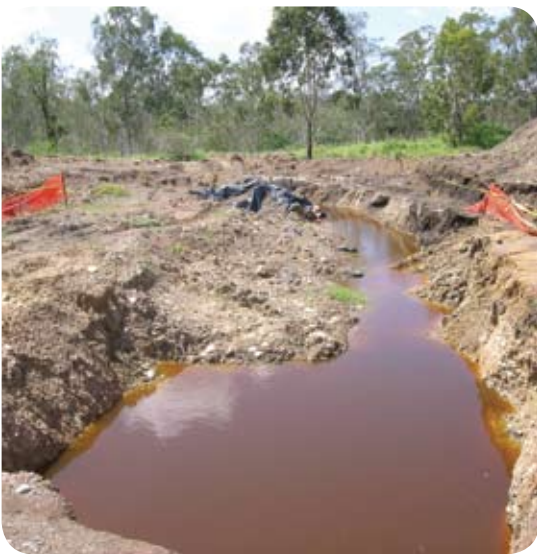
*Excavated area before treatment with
ViroFlow™ Technology*

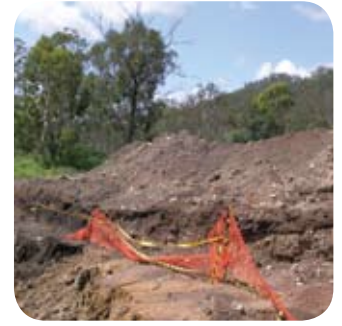
Contaminated stock pile of soil prior to treatment

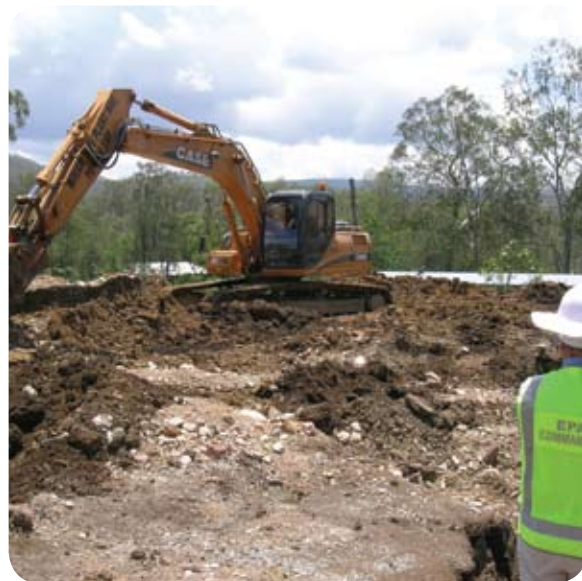
Contaminated soil being excavated so treatment can commence

The contaminated soil was excavated, loaded onto large trucks for transport to an off-site treatment facility and treated using Virotec's ViroFlow™ Technology and ViroBond™ reagent. The treated soil was then analysed to ensure that the copper, chromium and arsenate concentrations were under the limits set by the Queensland EPA for landfill disposal. The total volume of contaminated soil excavated and treated was about 600 cubic meters.

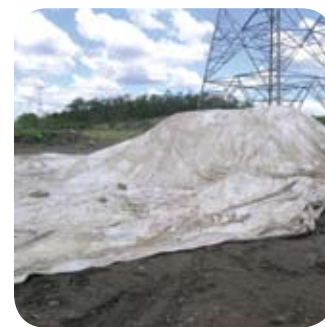
Stock pile of contaminated soil prior to treatment at external facility

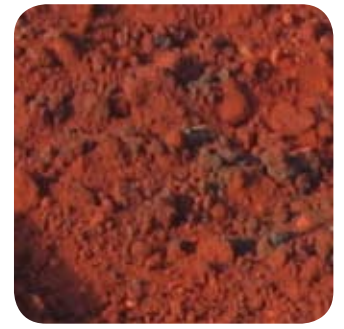
Treated soil after ViroBond™ reagent addition

The results show that the use of ViroBond™ reagent enables the concentrations of leachable copper, chromium and arsenate to be lowered to levels that are several orders of magnitude below the Queensland EPA limits; leachable arsenate concentrations fell to below the detection limit of 1 µg/L (Table 2).

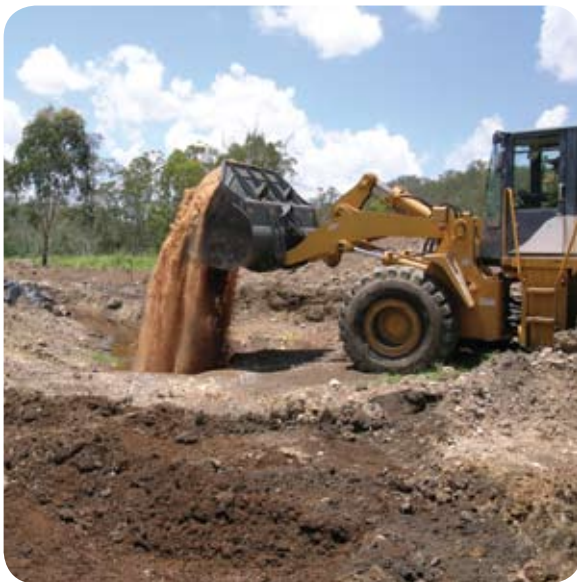
Excavation of contaminated soil
