*A COMMERCIAL APPLICATION OF
VIROFLOW™ TECHNOLOGY*

**CASE STUDY
PILK'S PINE, LOWANNA, NSW
CCA - CONTAMINATED SOIL,
LIQUID AND SLUDGE TREATMENT
AND DISPOSAL**

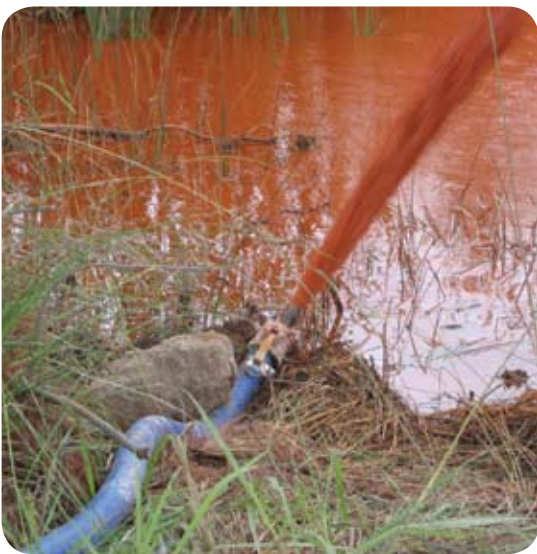
*Dosing of ViroBind™ reagent into
leachate pool.*

The ViroBond™ reagent was premixed in a mixing vessel and subsequently sprayed over the surface of the pond. The spent reagent was then allowed to settle and form a blanket over the bottom of the pond, where metals were permanently trapped.

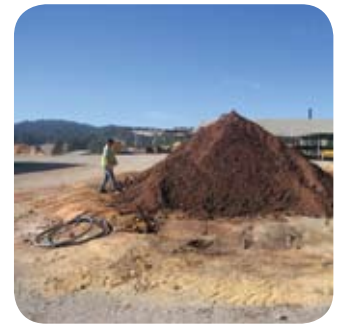
A portion of the untreated CCA solid waste prior to treatment

Virotec's proprietary ViroBond™ reagent is used for the treatment and immobilisation of copper, chromium and arsenic. ViroBond™ reagent was mixed with the solid waste on an impermeable clay-lined surface, using earth-moving equipment. The total volume treated was about 60 m3.

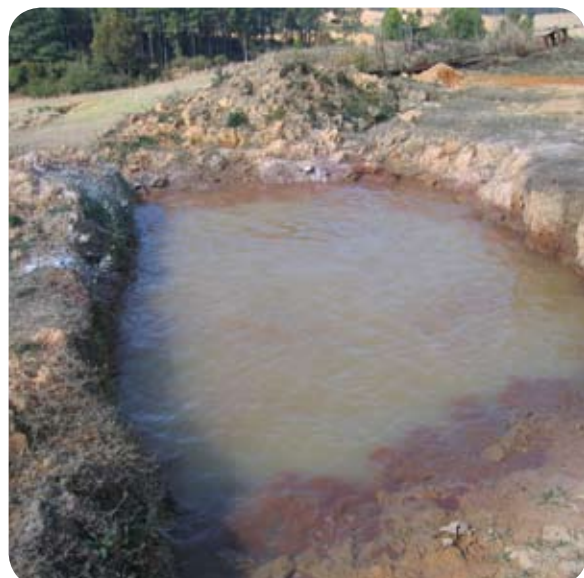
Water contained in the pit shown above was also treated using ViroFlow™ Technology.

In response to a request from Pilk's Pine, Virotec Global Solutions also used ViroFlow™ Technology to treat the water in a 1,000,000 L leachate pond, after adding all of the contaminated water from a nearby pit (2,000 L). The treatment was designed to immediately lower copper, chromium and arsenic (CCA) concentrations to below NSW EPA treatment targets; and to improve overall water clarity. The affected pond had CCA loads that exceeded discharge limits and there was a need to minimise environmental risk. The sludge in the bottom of the pond was also contaminated and needed to be isolated.

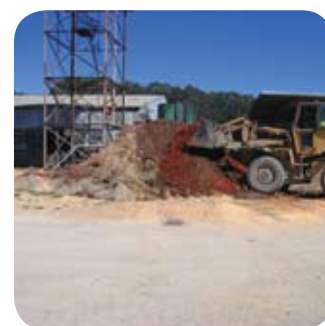
Treatment was applied using a loader.

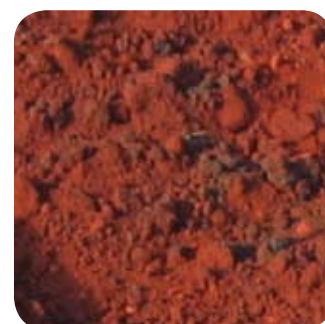
Treated soil after ViroBond™ reagent addition

The results of the solid waste treatment are shown in Table 1, together with the NSW EPA criteria for disposal as ordinary landfill. Meeting the TCLP (Toxicity Characteristic Leaching Procedure, US EPA) criteria is essential if the treated waste material is to be disposed of as ordinary (environmentally benign) landfill.

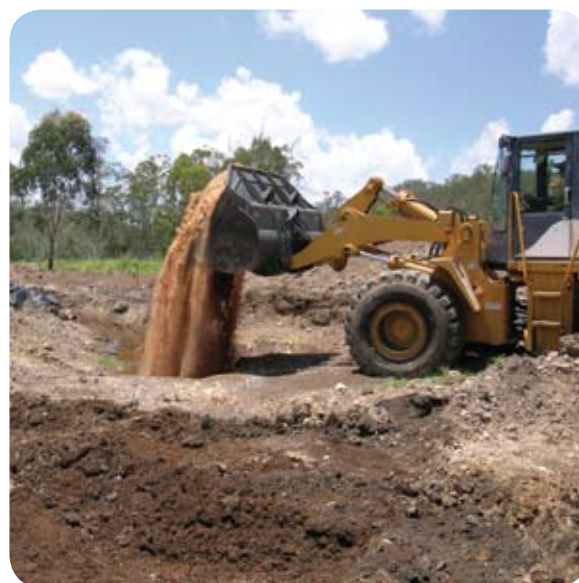
Treated CCA stockpile after ViroFlow™ Treatment

ViroFlow™ Technology successfully treated all the CCA contaminated solids to a sufficiently high standard that they met the New South Wales EPA criteria for disposal of liquid and non-liquid waste in landfill.
