*A COMMERCIAL APPLICATION OF  
VIROMINE™ TECHNOLOGY*

## CASE STUDY THALANGA COPPER MINES HIGHWAY REWARD SITE

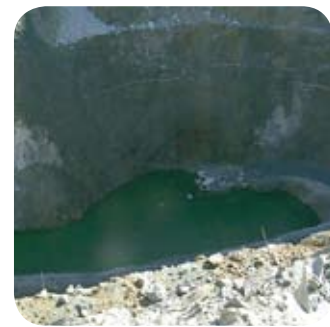
*The Highway Reward mine pit*

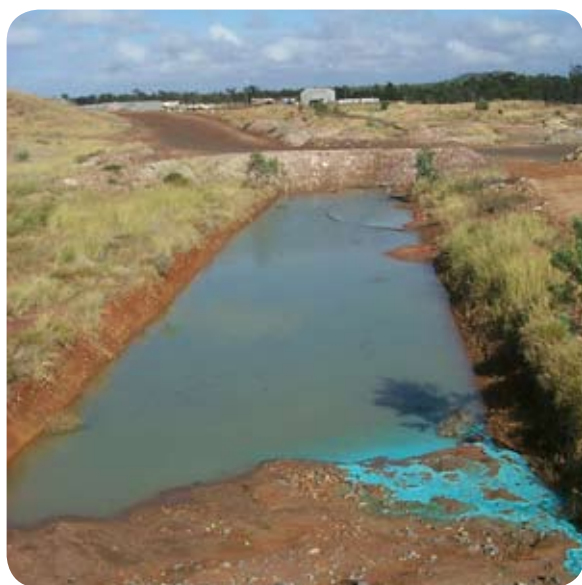
*One of the contaminated sediment ponds at Thalanga*

Acid B™ reagent was prepared in a mobile bulk test plant and sprayed onto the surface of the four contaminated ponds. The good dispersion properties of this reagent ensured that there was an even coverage. The treatment produced an extremely thin and dense sediment that subsequently acted as a passive barrier for treatment of further ingress of acid rock drainage water inflows.

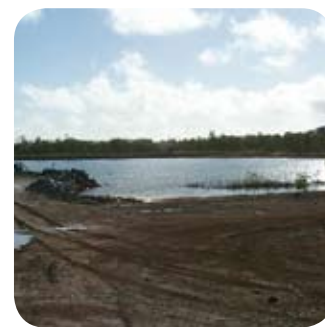
*The tailings dam at Thalanga*

When underground mining commenced, large quantities of mine water needed to be pumped to the surface; this water was collected in an old tailings dam. In the view of onsite personnel, the volume of water being pumped from underground would have soon exceeded the capacity of the tailings dam and they anticipated the need to release water all year round. During the dry season Thalanga Copper Mines did not have the benefit of being able to dilute the water before release and therefore another method for treatment was required. As an interim step, the mine was also considering raising the dam wall to provide a greater holding capacity.

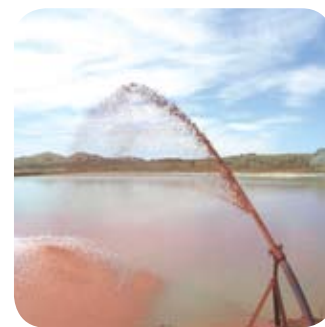
*The ViroMine™ Technology reagent was applied by a simple direct addition method*

The *in-situ* treatment method used involved no expensive capital infrastructure and a simple application procedure (see image overleaf).
