*A COMMERCIAL APPLICATION OF  
VIROSEWAGE™ TECHNOLOGY*

## CASE STUDY KILCOY SEWAGE TREATMENT PLANT

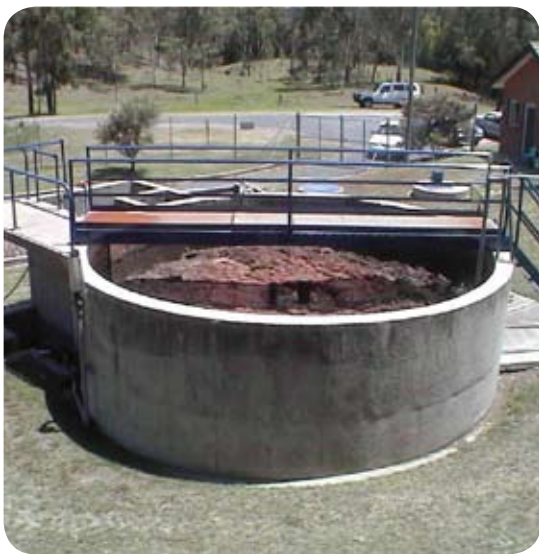
*An overview of the Sewage Treatment Plant.*

The Kilcoy Sewage treatment plant utilizes trickle filtration for the treatment of sewage. The sewage is collected from the township of 1,800-2,000 people. The average daily hydraulic flow is approximately 400 kL with peak flow periods from 6:00 am to 10:30 am daily.

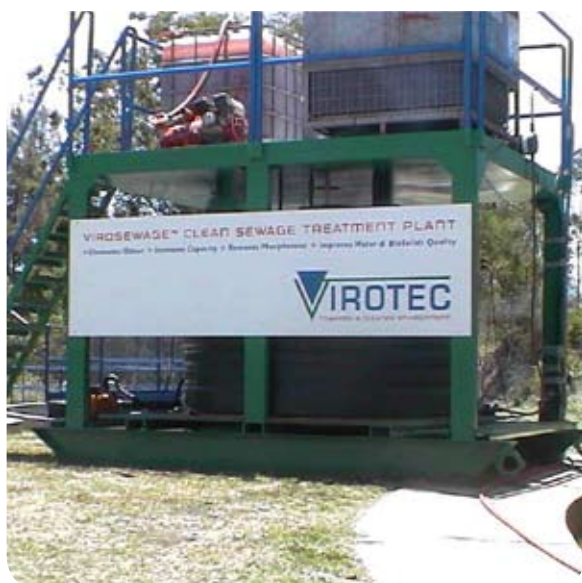
The ViroSewage™ Technology dosing plant at Kilcoy sewage treatment works.

The ViroSewage™ Technology treatment method is a fairly simple add-on to the existing treatment plant and does not require significant capital investment. The ViroSewage™ Technology dosing plant is linked to the sewage treatment plant's flow meter to ensure correct dosing of ViroSewage™ Technology reagents during the variable input flows.

ViroSewage™ Technology consisted of dosing the outflow from the trickle filter prior to the input to the secondary clarifier with ViroSewage™ Technology reagents and monitoring the resultant outflow. ViroSewage™ Technology showed a marked improvement of the visual clarity of water in both the secondary clarifier and the chlorination tank. Visual clarity improved from an initial 200 mm depth to over 2,200 mm depth after only 14 hours of operation. It was also found that the phosphorus concentration was reduced from 14 mg/L to 0.05 mg/L. The colour and turbidity were also reduced from 35 PCU and 16 NTU respectively to 10 PCU and 1 NTU.
